**HOPE** TECHNICAL DEVELOPMENTS Ltd

**PROTECTING YOUR VAN FROM REAR DAMAGE**

**safe-T-bar**

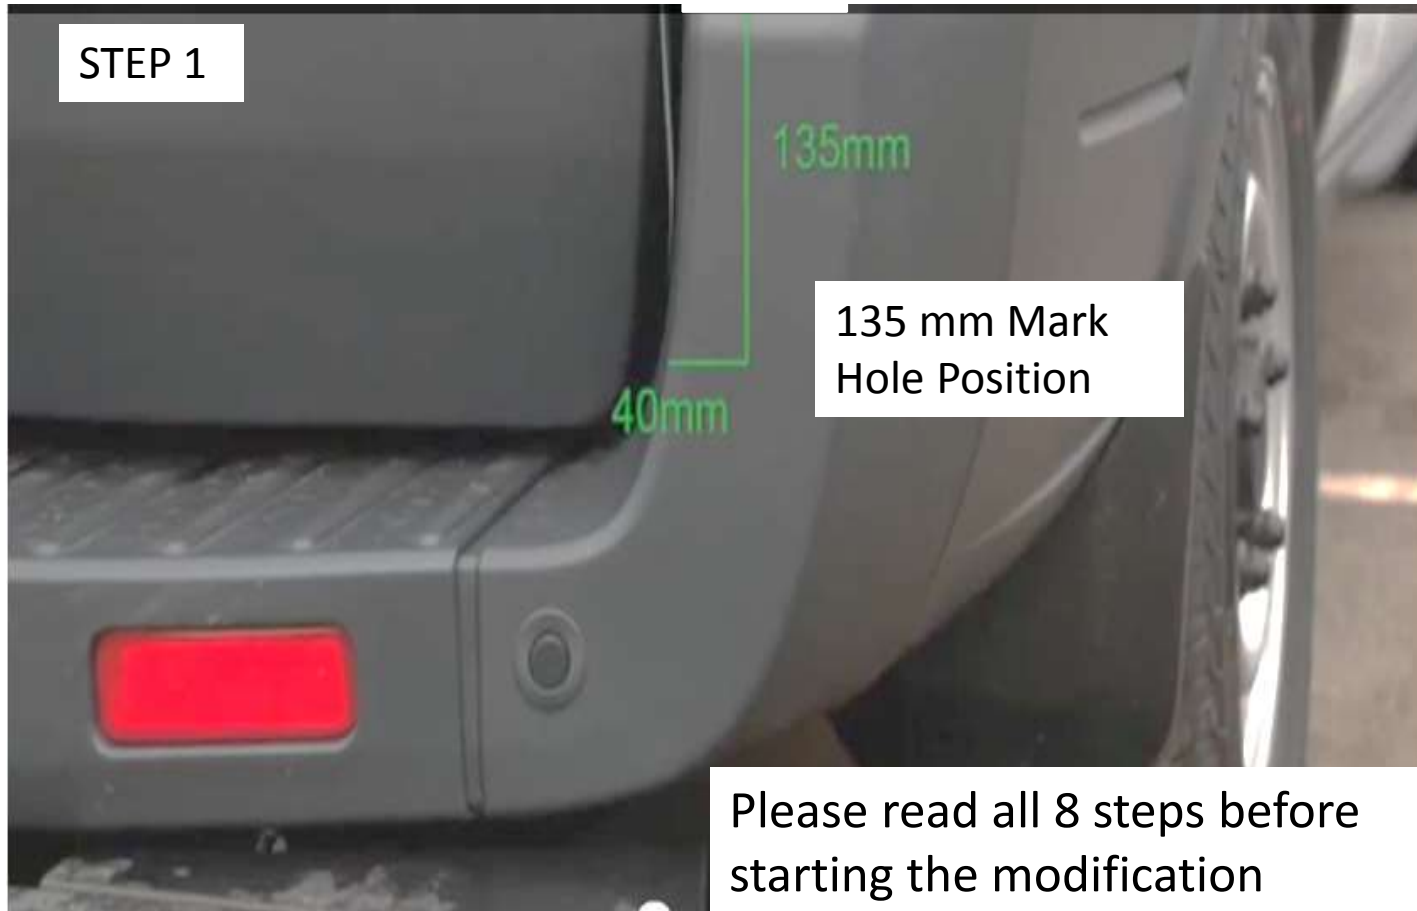
STEP 1

135 mm Mark  
Hole Position

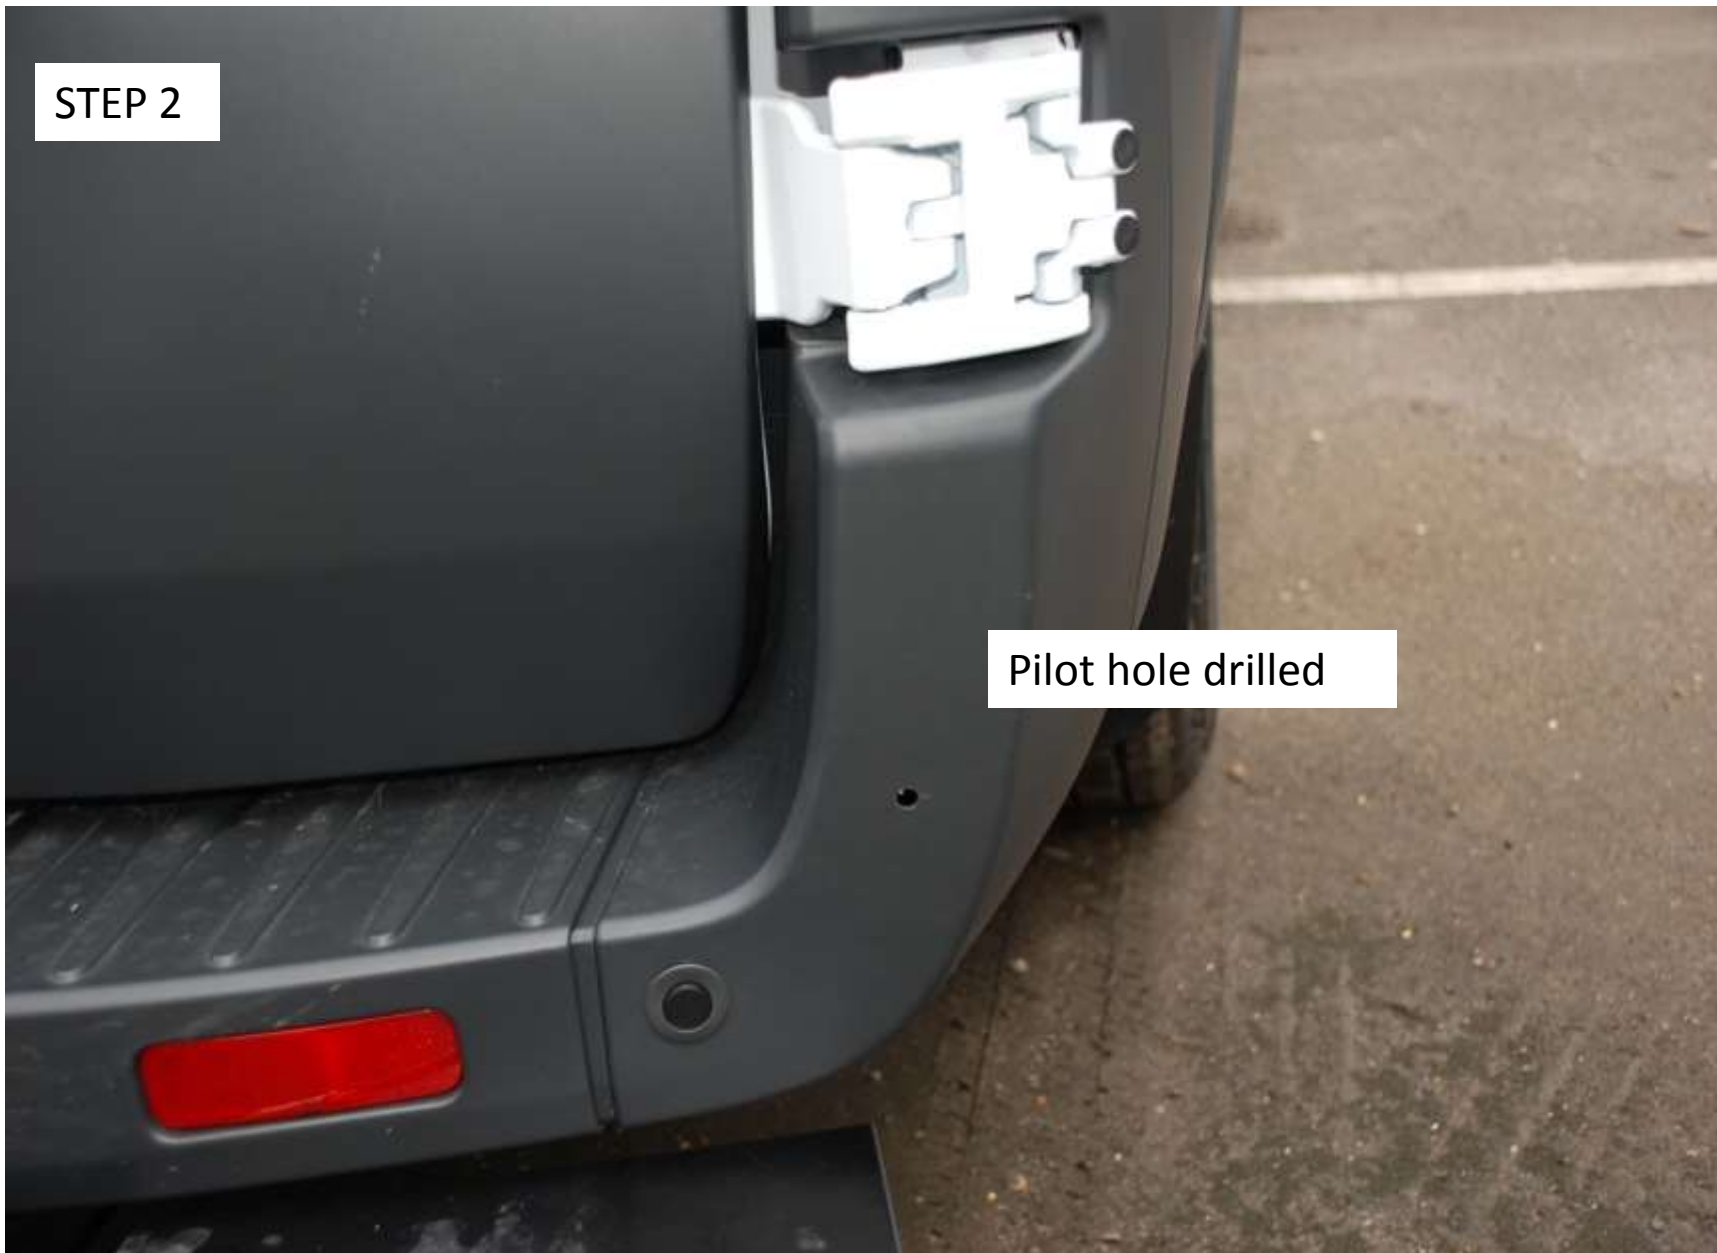
STEP 2

Pilot hole drilled

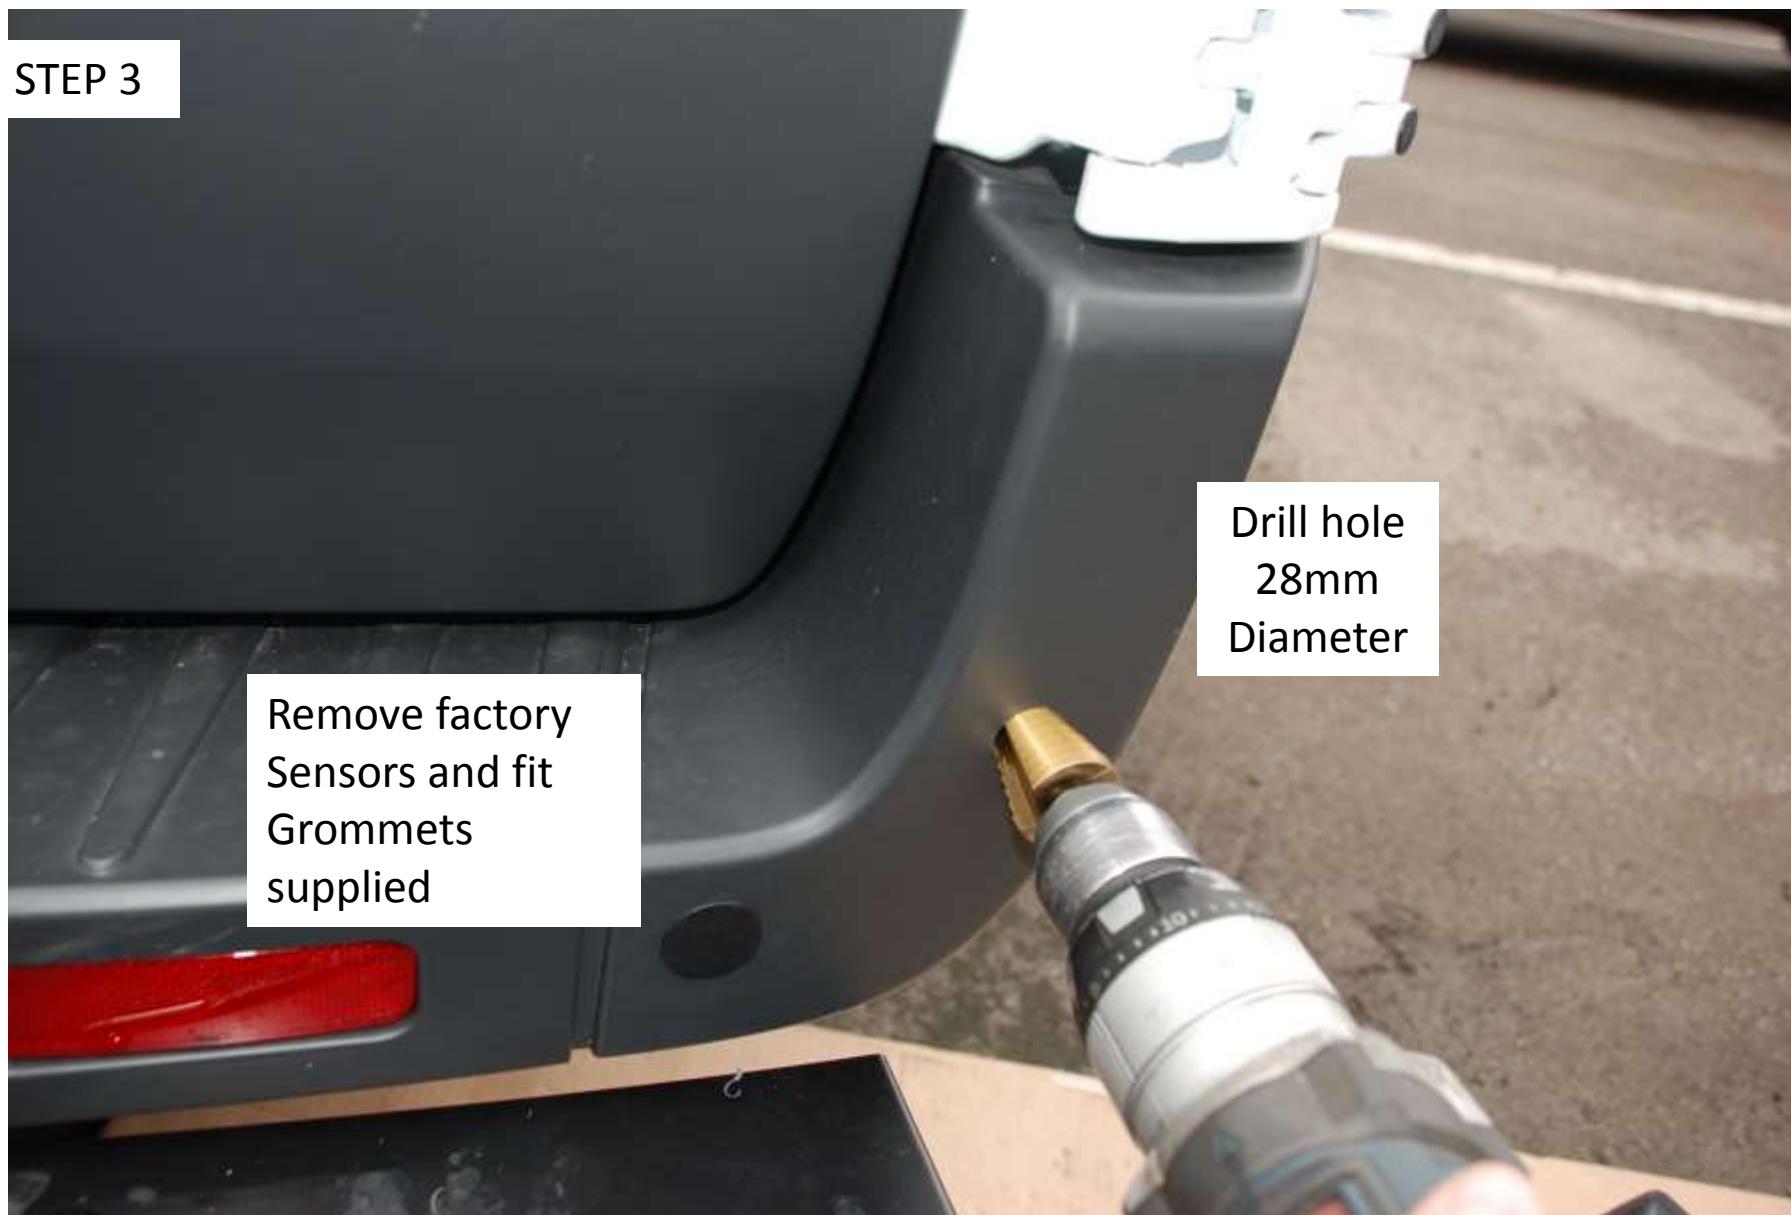
### STEP 3

Remove factory  
Sensors and fit  
Grommets  
supplied

Drill hole  
28mm  
Diameter

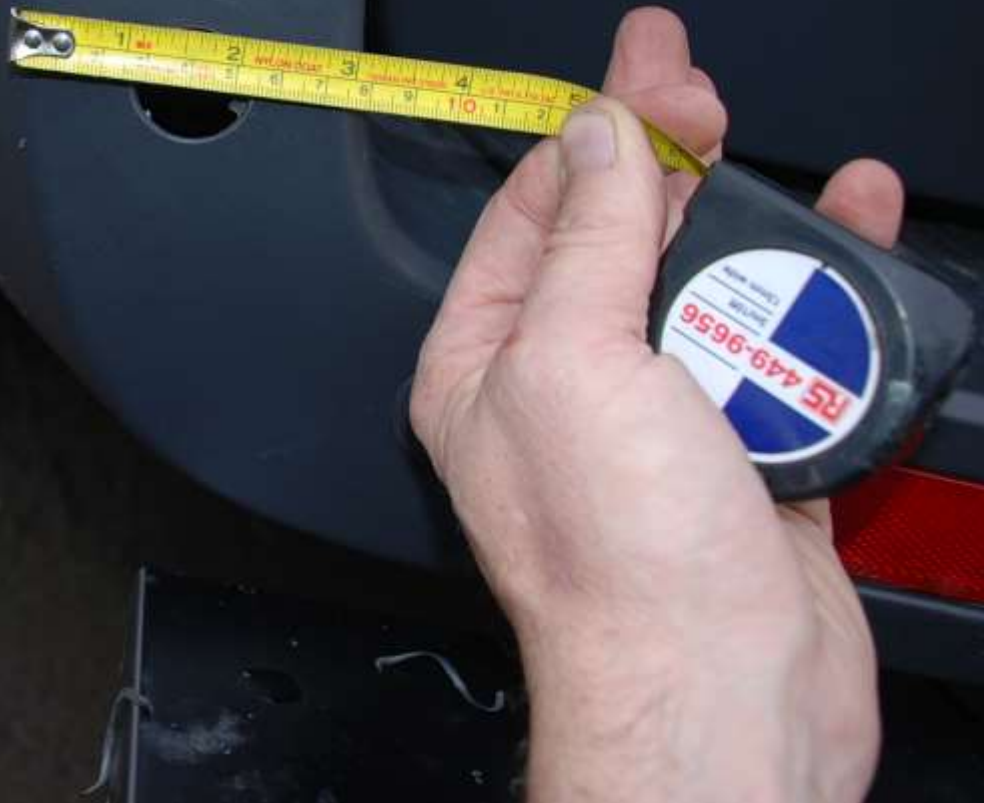
## STEP 4

Ensure hole  
position is  
central

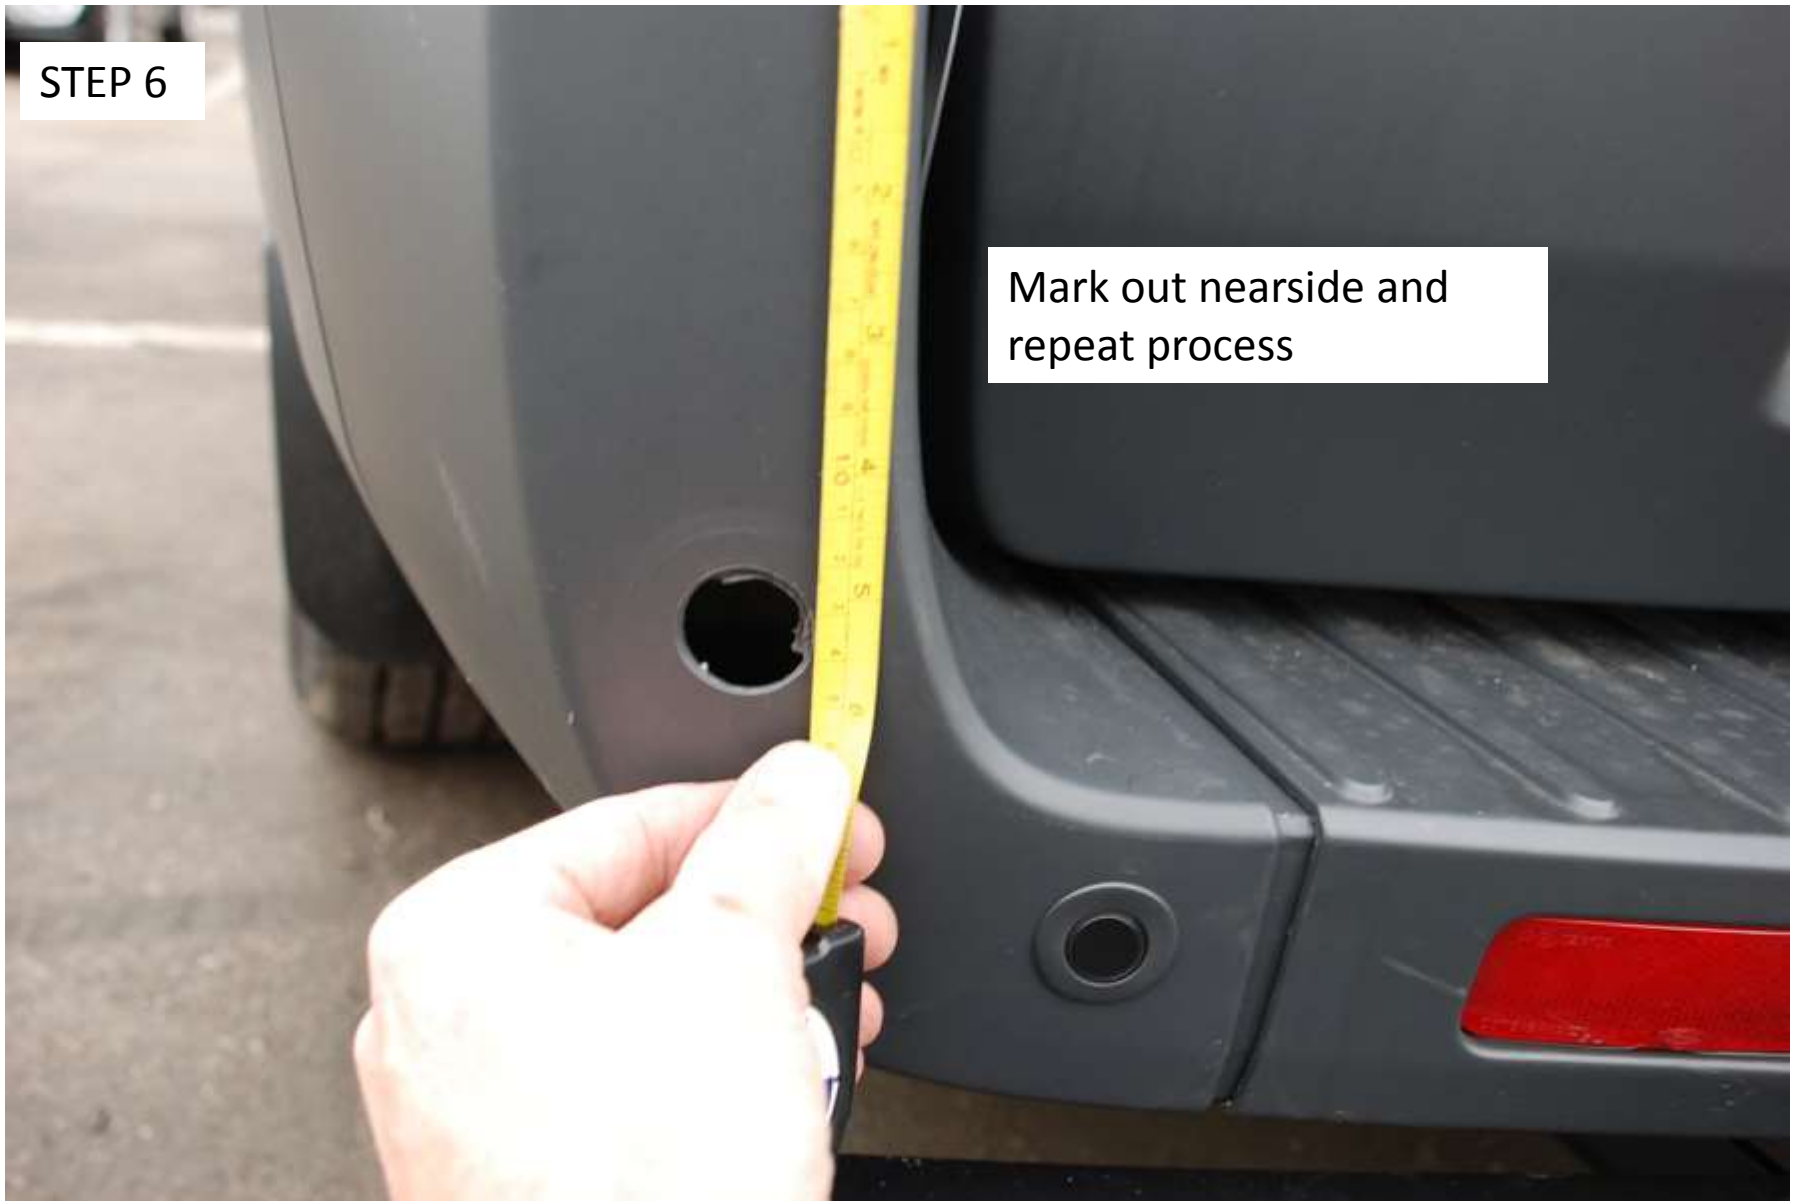
STEP 6

Mark out nearside and  
repeat process

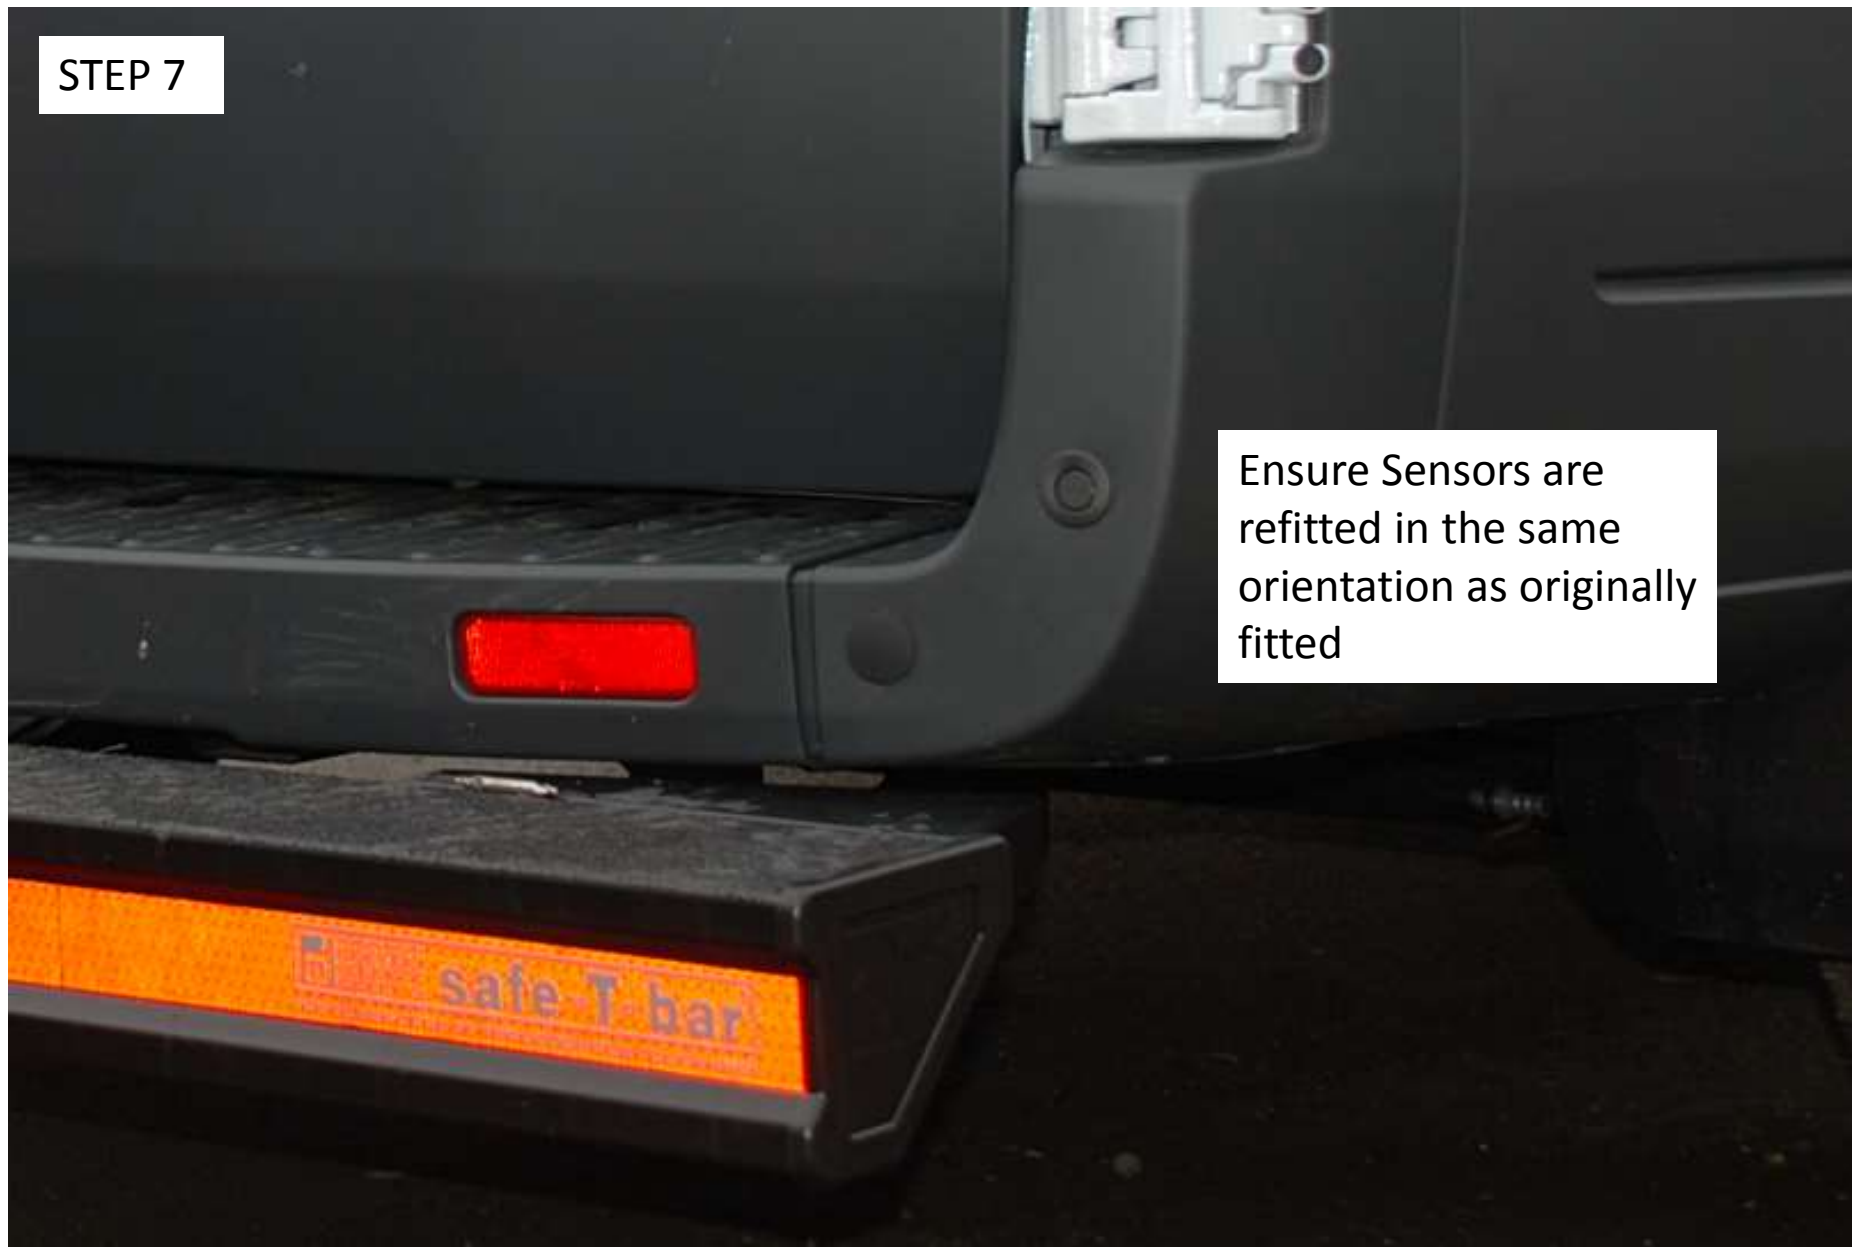
## STEP 7

Ensure Sensors are refitted in the same orientation as originally fitted

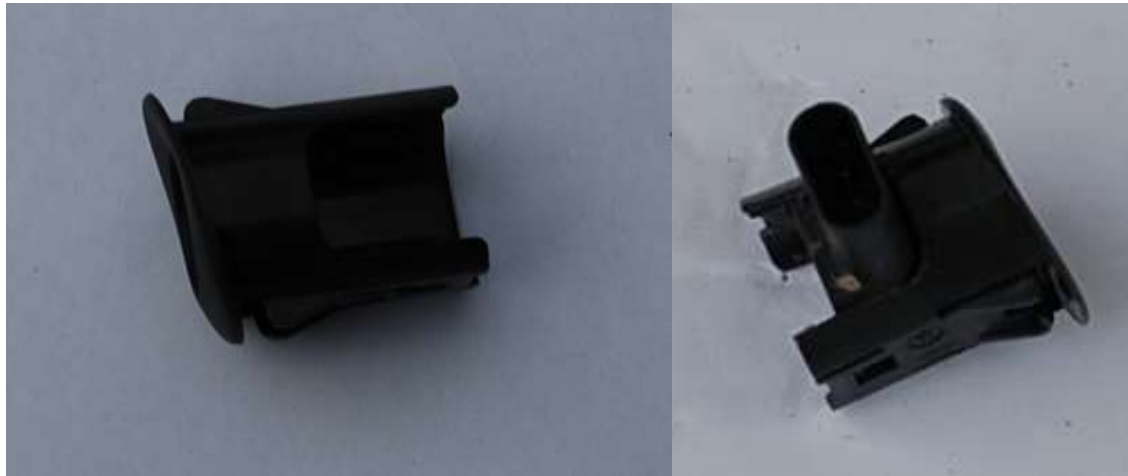
## STEP 8

The nearside sensor housing will need modification to allow the sensor cable plug to exit on the opposite side to original.

This is achieved by cutting a new slot on the opposite side of the housing as seen in the picture
